ENGINE—4.6L—OIL LEAK FROM HEAD GASKET AREA—ROMEO BUILT ENGINES ONLY	Article No. 01-21-10
--	---------------------------------

FORD: 1998 MUSTANG
1998-2000 CROWN VICTORIA
1998-1999 F-250 LD
1998-2000 EXPEDITION, F-150
1999-2000 E SERIES

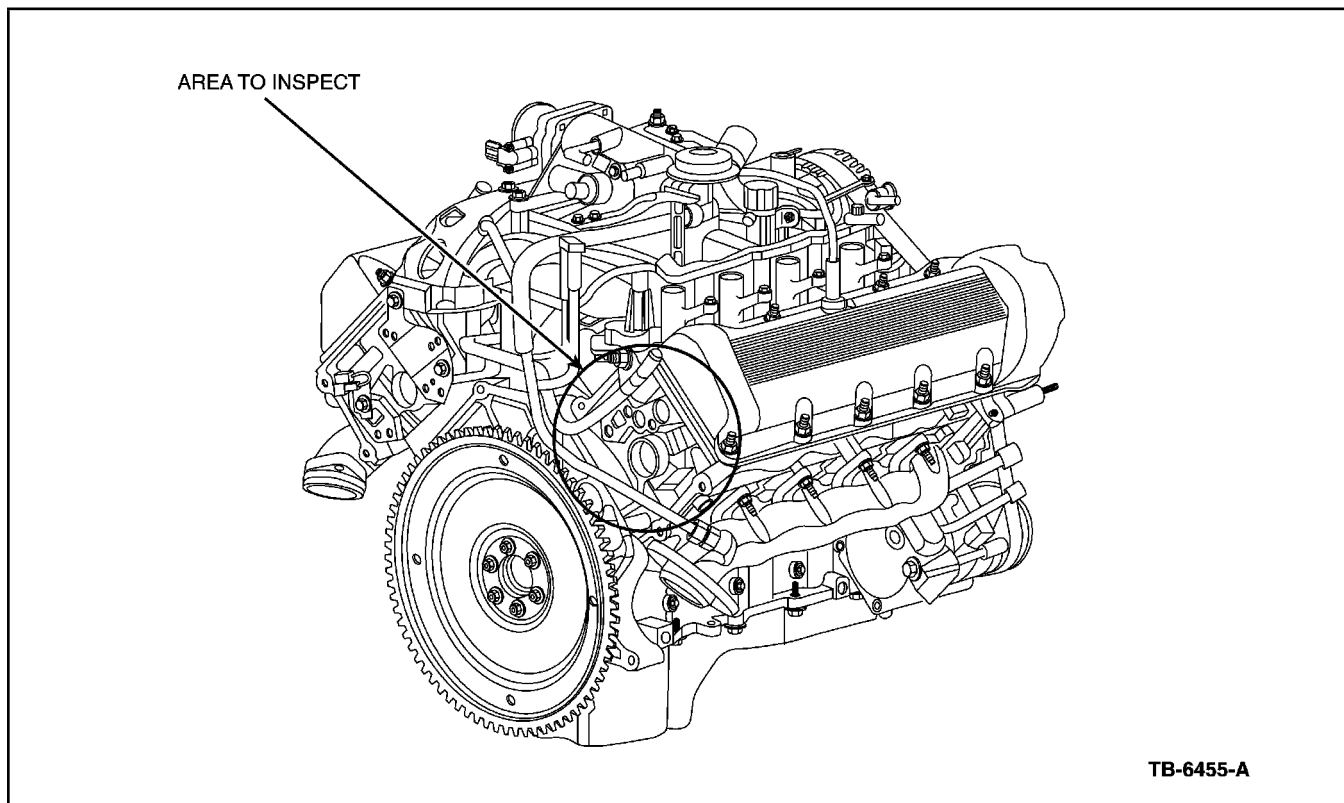
Figure 1 - Article 01-21-10

Always verify the origin of an oil leak by using fluorescent dye. At times, a Cam Cover Gasket or engine Oil Galley Plug (particularly at the rear of the right hand head) may be the source of the engine oil leak. (Figure 1)

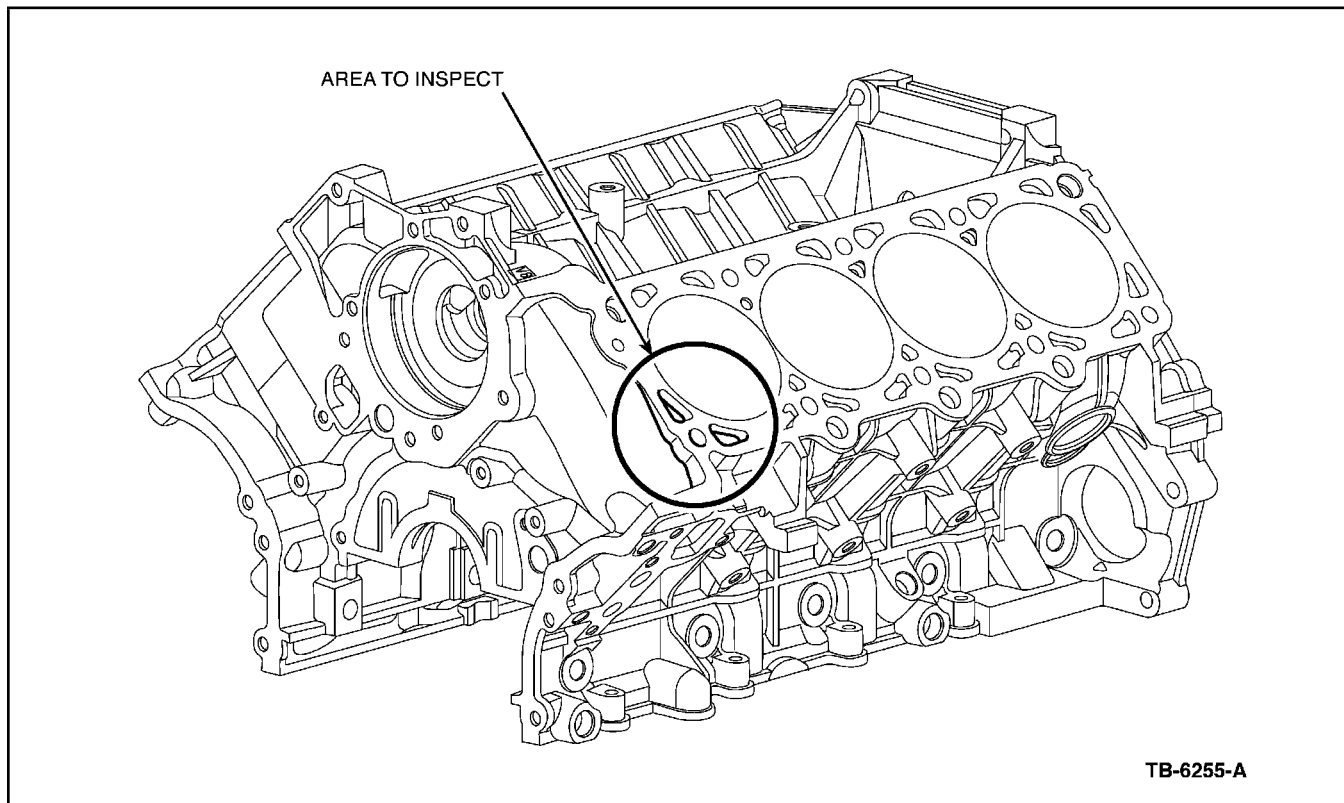
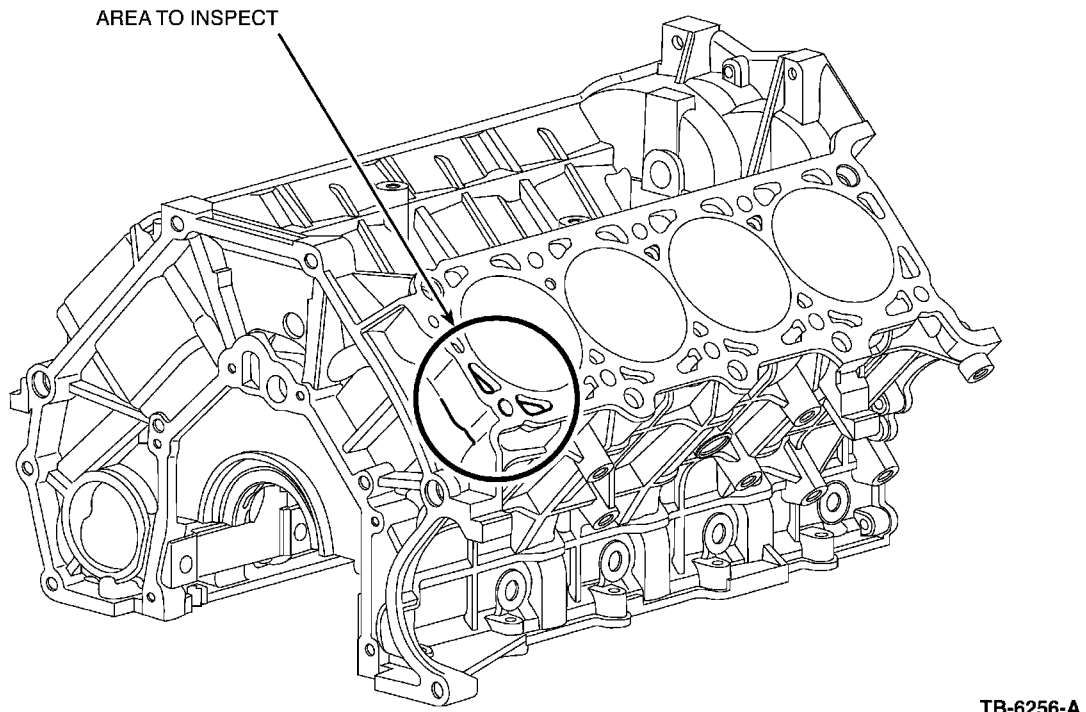
- During normal inspection, pay particular attention to the RIGHT bank block deck area behind cylinder #4 or the LEFT bank block deck area in front of cylinder #5 around the oil hole breakout for dimples and impressions left by metal chips (Figures 2 and 3).

- The block surface around the cylinder head alignment dowels (2 per bank) is another common location for scratches or dimples.
- A known quality straight edge should be used to ensure the block surface is flat. If a dimple or impression measures over .001" (.025mm) deep, it is recommended to replace the block. This type of damage is rare.

- If block does not pass checks, a new or remanufactured long block engine assembly must be ordered. For truck applications, which require use of the Modular Engine Lift Bracket 303-F047 (014-00073) for engine removal, use nine links of 5/16 " chain in place of the rear bracket (Figure 4).
