NOISE—"POPPING" OR "OIL CANNING" NOISE FROM DRIVER'S FOOTWELL AREA

Article No.
99-22-6

FORD: 1999-2000 MUSTANG

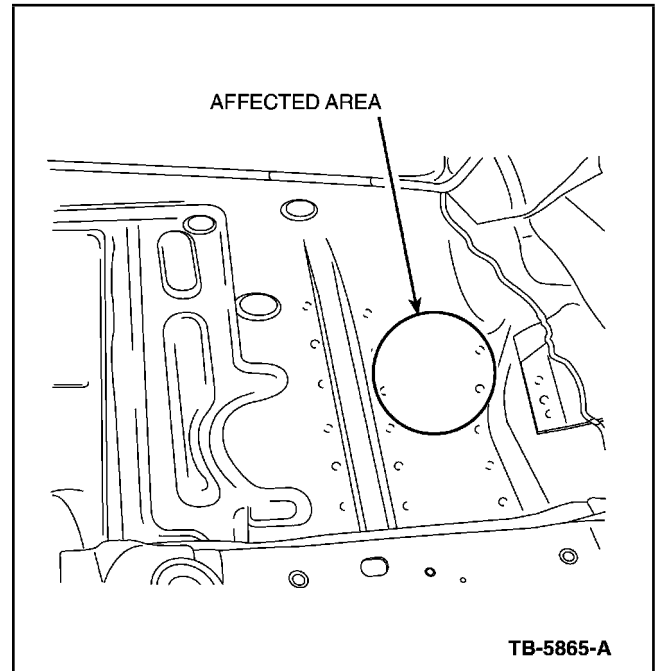
Figure 1 - Article 99-22-6

A "popping" or "oil canning" noise may be coming from the driver's footwell area, approximately 152-203mm (6-8") rearward of where the driver's heel would rest when operating the accelerator pedal.

1. Disconnect the battery and wait 2 minutes. This will deactivate the air bag module and prevent an inadvertent air bag deployment.
2. Pull back the carpet covering the affected area. Refer to Figure 1 for approximate location.
3. Using a 1 lb. hammer, strike the floor pan and form approximately a 25mm (1") long cross-car stiffening bead in the area of oil canning. Refer to Figure 2.
4. Verify that pressure in the affected area no longer causes the oil canning effect.
5. Reinstall carpeting.
6. Reconnect battery.
