<ul style="list-style-type: none"> • LAMP—INTERMITTENT MALFUNCTION INDICATOR LAMP (MIL) ILLUMINATION—DIAGNOSTIC TROUBLE CODES (DTCS) P0741, P0750, P0755, AND P1746 MAY BE STORED IN MEMORY—VEHICLES BUILT FROM 8/1/1998 THROUGH 5/1/1999 WITH 4R70W TRANSMISSION • LAMP—INTERMITTENT TRANSMISSION CONTROL INDICATOR LAMP (TCIL) ILLUMINATION—DIAGNOSTIC TROUBLE CODES (DTCS) P0741, P0750, P0755, AND P1746 MAY BE STORED IN MEMORY—VEHICLES BUILT FROM 8/1/1998 THROUGH 5/1/1999 WITH 4R70W TRANSMISSION • TRANSMISSION—4R70W—INTERMITTENT TRANSMISSION CONTROL INDICATOR LAMP (TCIL) ILLUMINATION—DIAGNOSTIC TROUBLE CODES (DTCS) P0741, P0750, P0755, AND P1746 MAY BE STORED IN MEMORY—VEHICLES BUILT FROM 8/1/1998 THROUGH 5/1/1999 	Article No. 99-19-7
---	--------------------------------

FORD: 1999 CROWN VICTORIA, MUSTANG, ECONOLINE, EXPEDITION, EXPLORER, F-150, F-250 LD

Article No. 99-19-7 Cont'd.

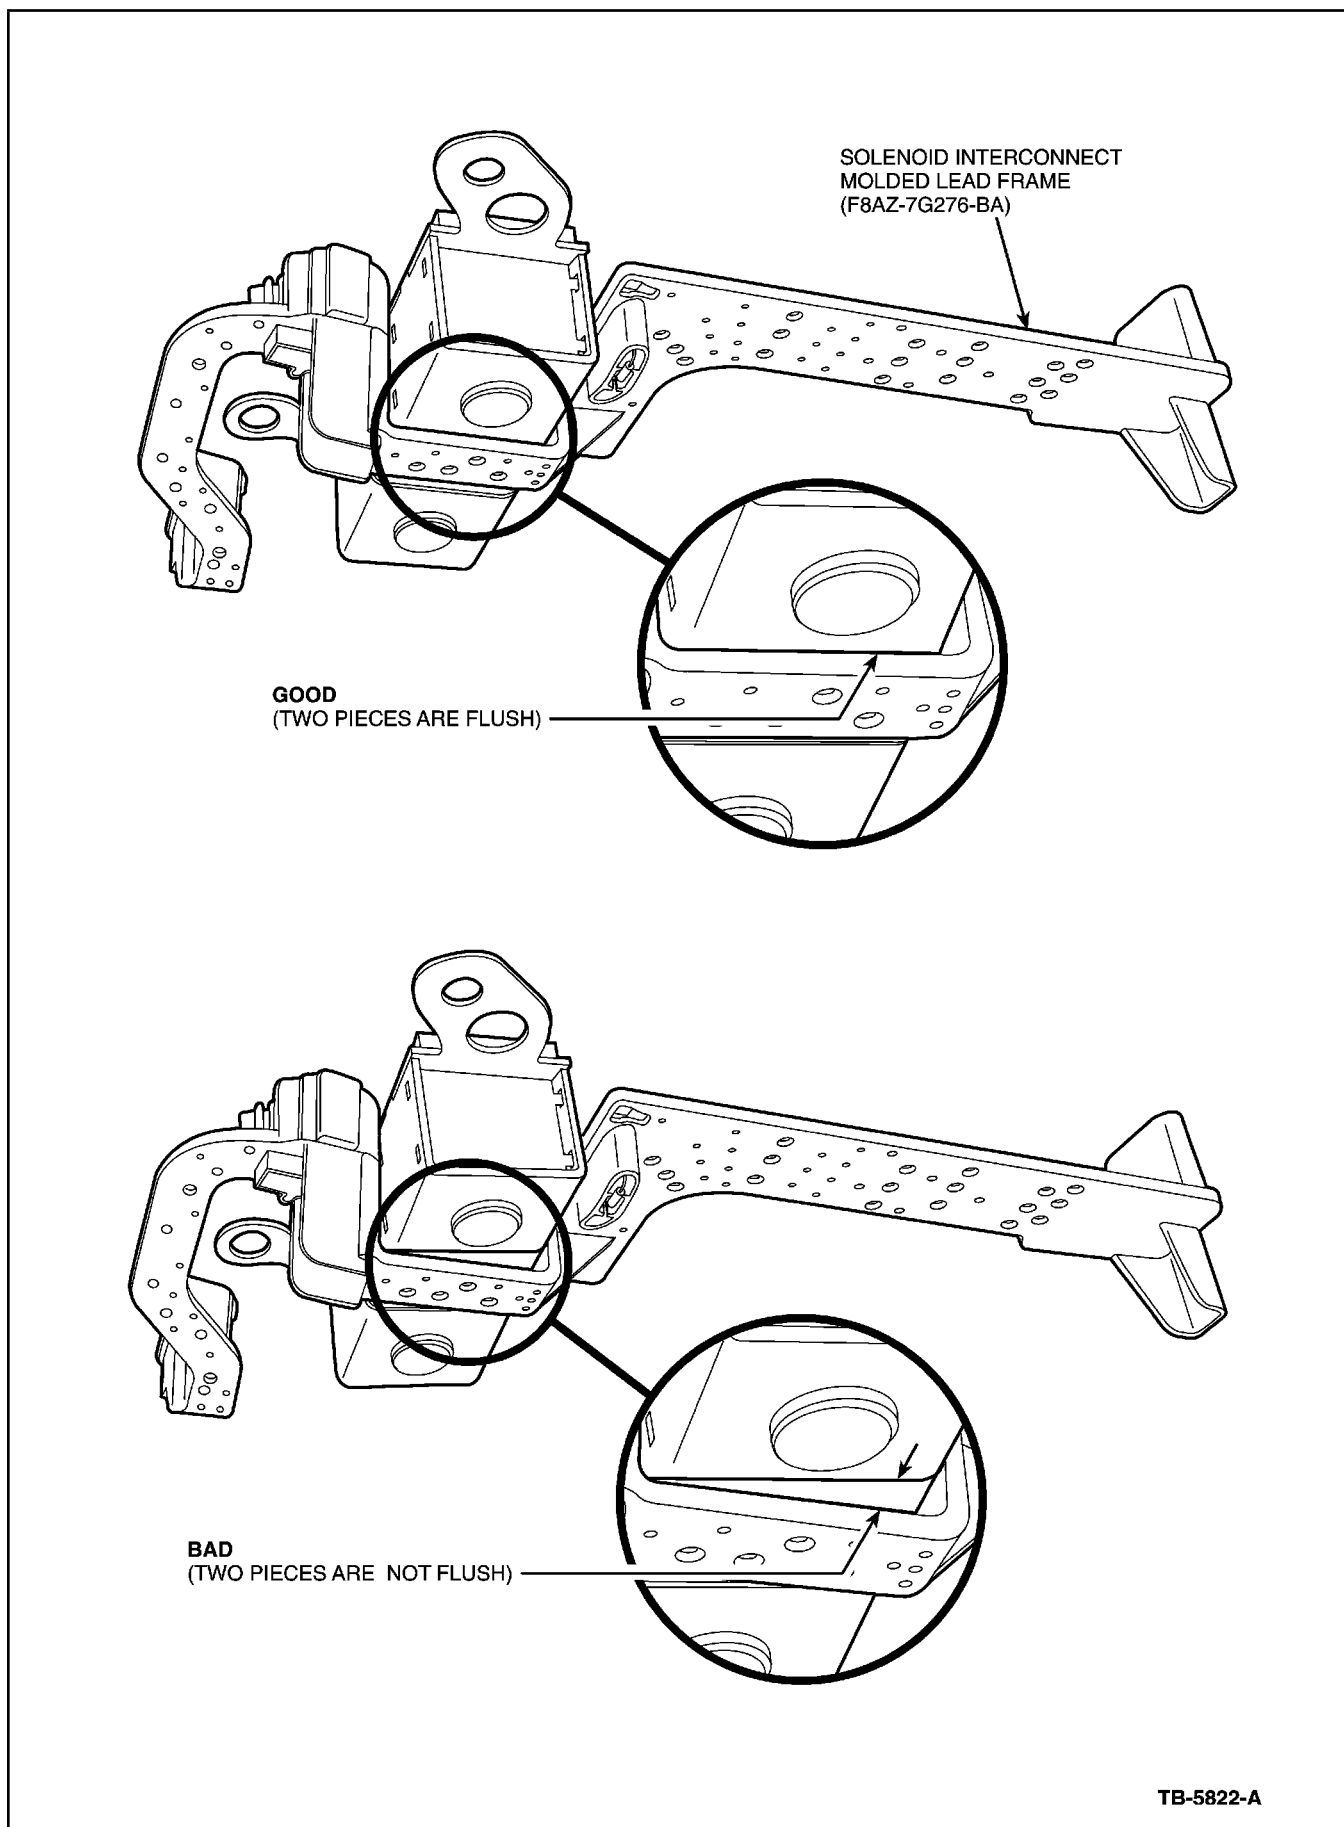
Figure 1 - Article 99-19-7

1. Perform normal diagnosis for DTCs retrieved as outlined in the appropriate 1999 Workshop Manual. If root cause is not determined, continue with this TSB.
2. Remove the transmission oil pan per the appropriate model Workshop Manual, Section 307-01.
3. Verify that the solenoid interconnect molded lead frame is fully seated on all the solenoid connectors (Figure 1). If the solenoid interconnect molded lead frame is fully seated, then gently remove the solenoid interconnect molded lead frame, valve body, and bulkhead interconnect (-7G276-) per the appropriate model Workshop Manual, Section 307-01.

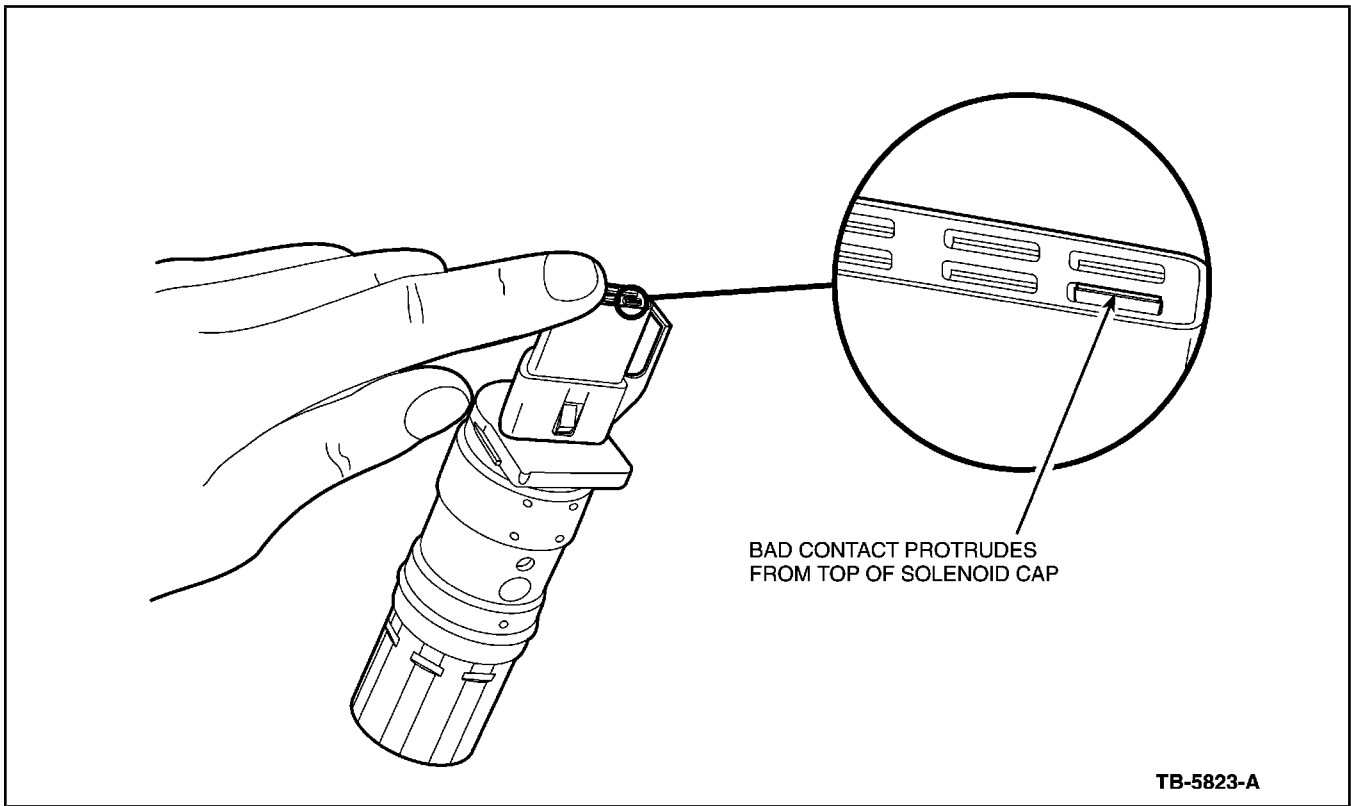
Figure 2 - Article 99-19-7

4. With the bulkhead interconnect removed, push down on the terminal cover and check to see if any of the terminals are slightly protruding above the plastic cover (Figure 2). Gently pry off the terminal cover using a small screwdriver (Figure 3). With the terminal cover off, inspect the bulkhead interconnect for spreading terminals (Figure 4). If the bulkhead interconnect terminals are spread or slightly protruding above the plastic cover, replace with a new Bulkhead Interconnect (F8AZ-7G276-AA).
5. Reassemble.
