- **BODY—"CREAKING" NOISE FROM LH REAR QUARTER AREA—CONVERTIBLES ONLY**
- **NOISE—"CREAKING" FROM LH REAR QUARTER AREA—CONVERTIBLES ONLY**

**Article No.
99-21-8**

FORD: 1999 MUSTANG

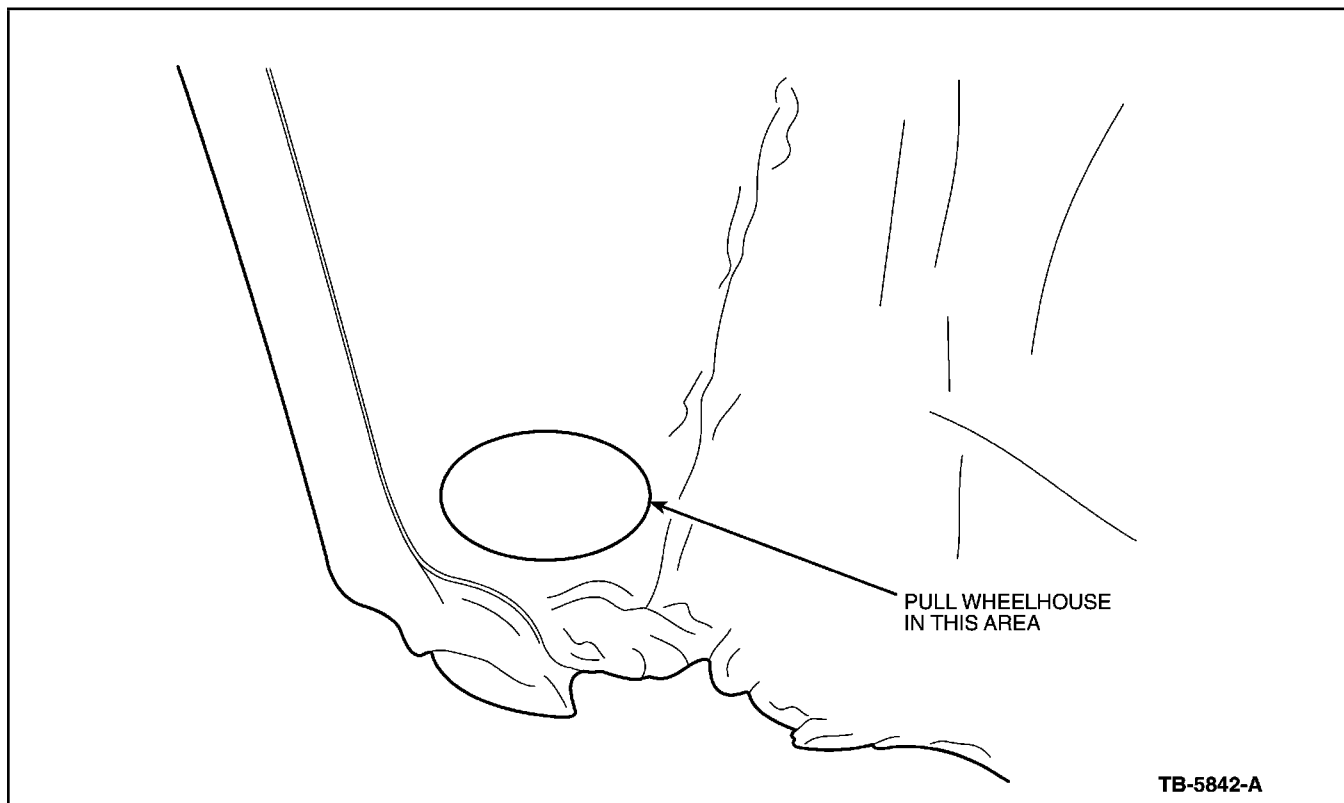
Figure 1 - Article 99-21-8

A "creaking" noise from the LH rear quarter area when going over bumps may be heard on some vehicles. This may be due to contact between the inner rocker panel and the outer wheelhouse of the LH rear quarter area.

1. Remove the left rear wheel.
2. Drill two (2) holes using a 1/8" drill bit into the wheelhouse (approximately 25mm (1") above the lower flange and 25mm (1") outboard of the wheelhouse seam).
3. Using a dent puller, pull the wheelhouse metal away from the rocker panel (Figure 1).
4. Redrive vehicle to make sure concern is repaired.
5. If concern is still present, repeat Steps 2-4 with two (2) more holes approximately 19mm (3/4") outboard of the wheelhouse seam. Do not drill more than a total of four (4) holes.

6. Spray over the holes with Super Seal Anti-Corrosion Compound (F3AZ-19515-SA or equivalent meeting Ford Specification ESR-M7C54-A).
