10 Pin Fix

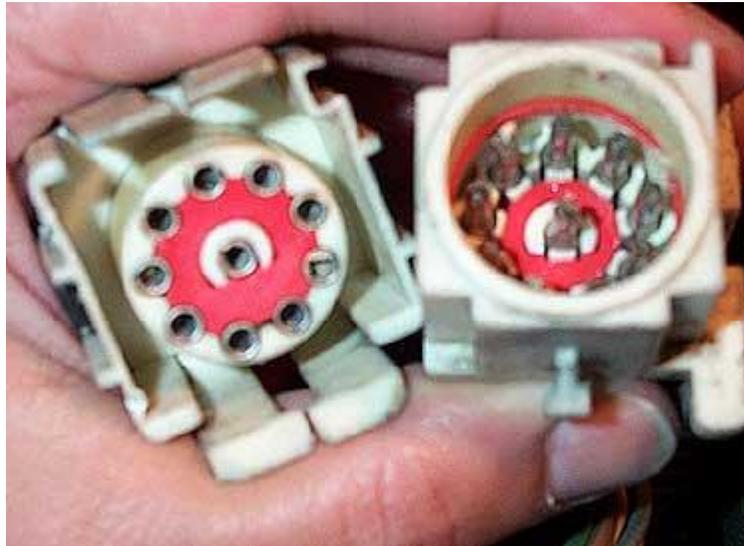
1. Disconnect the negative battery cable! To open the connectors squeeze the four side clips and pull apart. Do not pry the clips apart as with other connectors. The inner workings reveal ten male and female connectors.
