10 Pin Fix

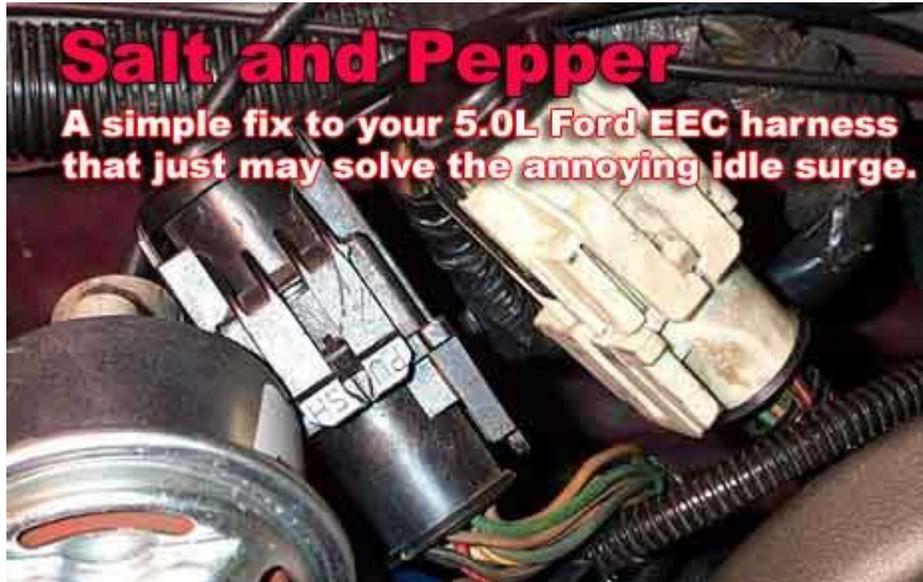
The "ten pin" connectors are these salt and pepper shaker looking things found at the back of 5.0L engines -between the intake manifold and firewall. These connectors are notorious for developing poor connections and causing strange EEC quirks, like idle fluctuations, check engine lights, and unexplainable diagnostic codes to be triggered. On many Mustangs there may be a dealer installed extension harnesses, making it appear as if there are a total of four of these connectors.
